The History of Kinghorn Loch introduced by Ron Edwards

from
creation to
now.....

A wonderful kettle hole lake

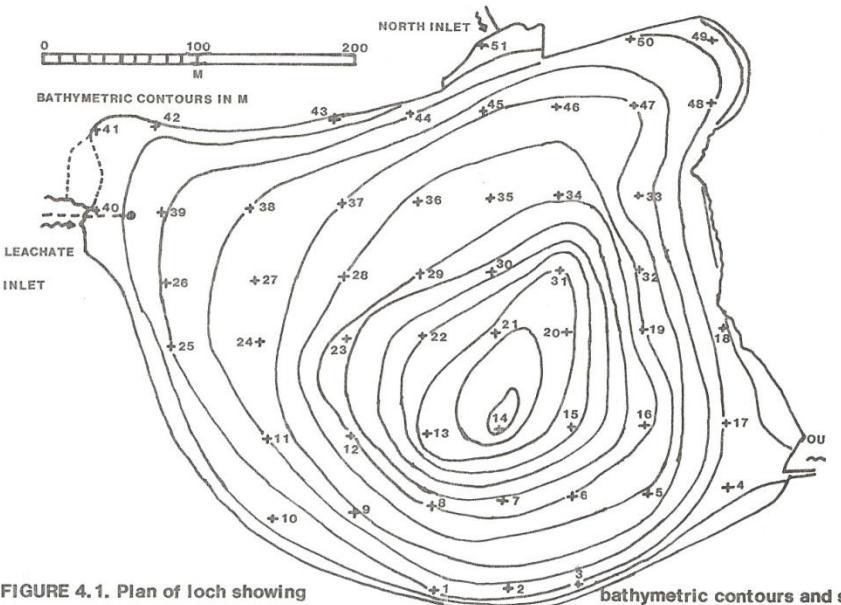
Profile of the loch

FIGURE 4.1. Plan of loch showing bathymetric contours and sampling stations.

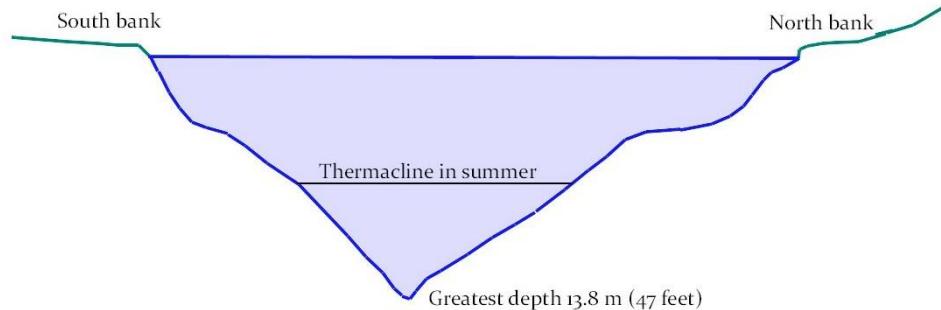
Cross-section of Kinghorn Loch

Kinghorn Loch is an example of a “kettle hole lake”, formed at the very end of the last Ice Age as the face of the Forth glacier retreated past Craigencalt.

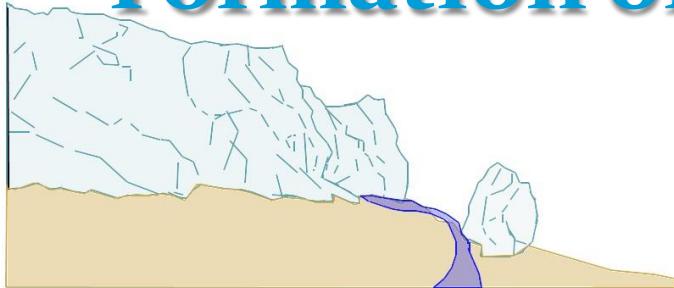
Formation of a kettle hole lake

A huge chunk of ice may break off the face of the glacier or ice sheet

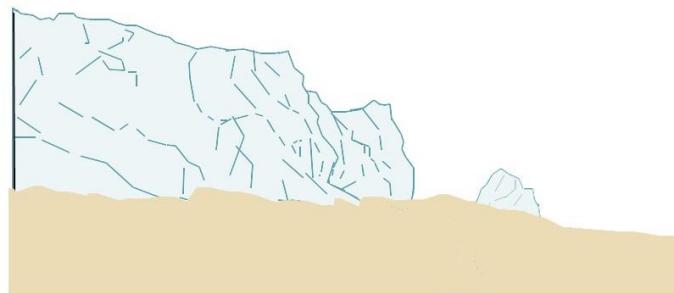
It becomes buried in outwash moraine gravels, sands and bounder clay

The ice melts and the hole fills up as a round loch

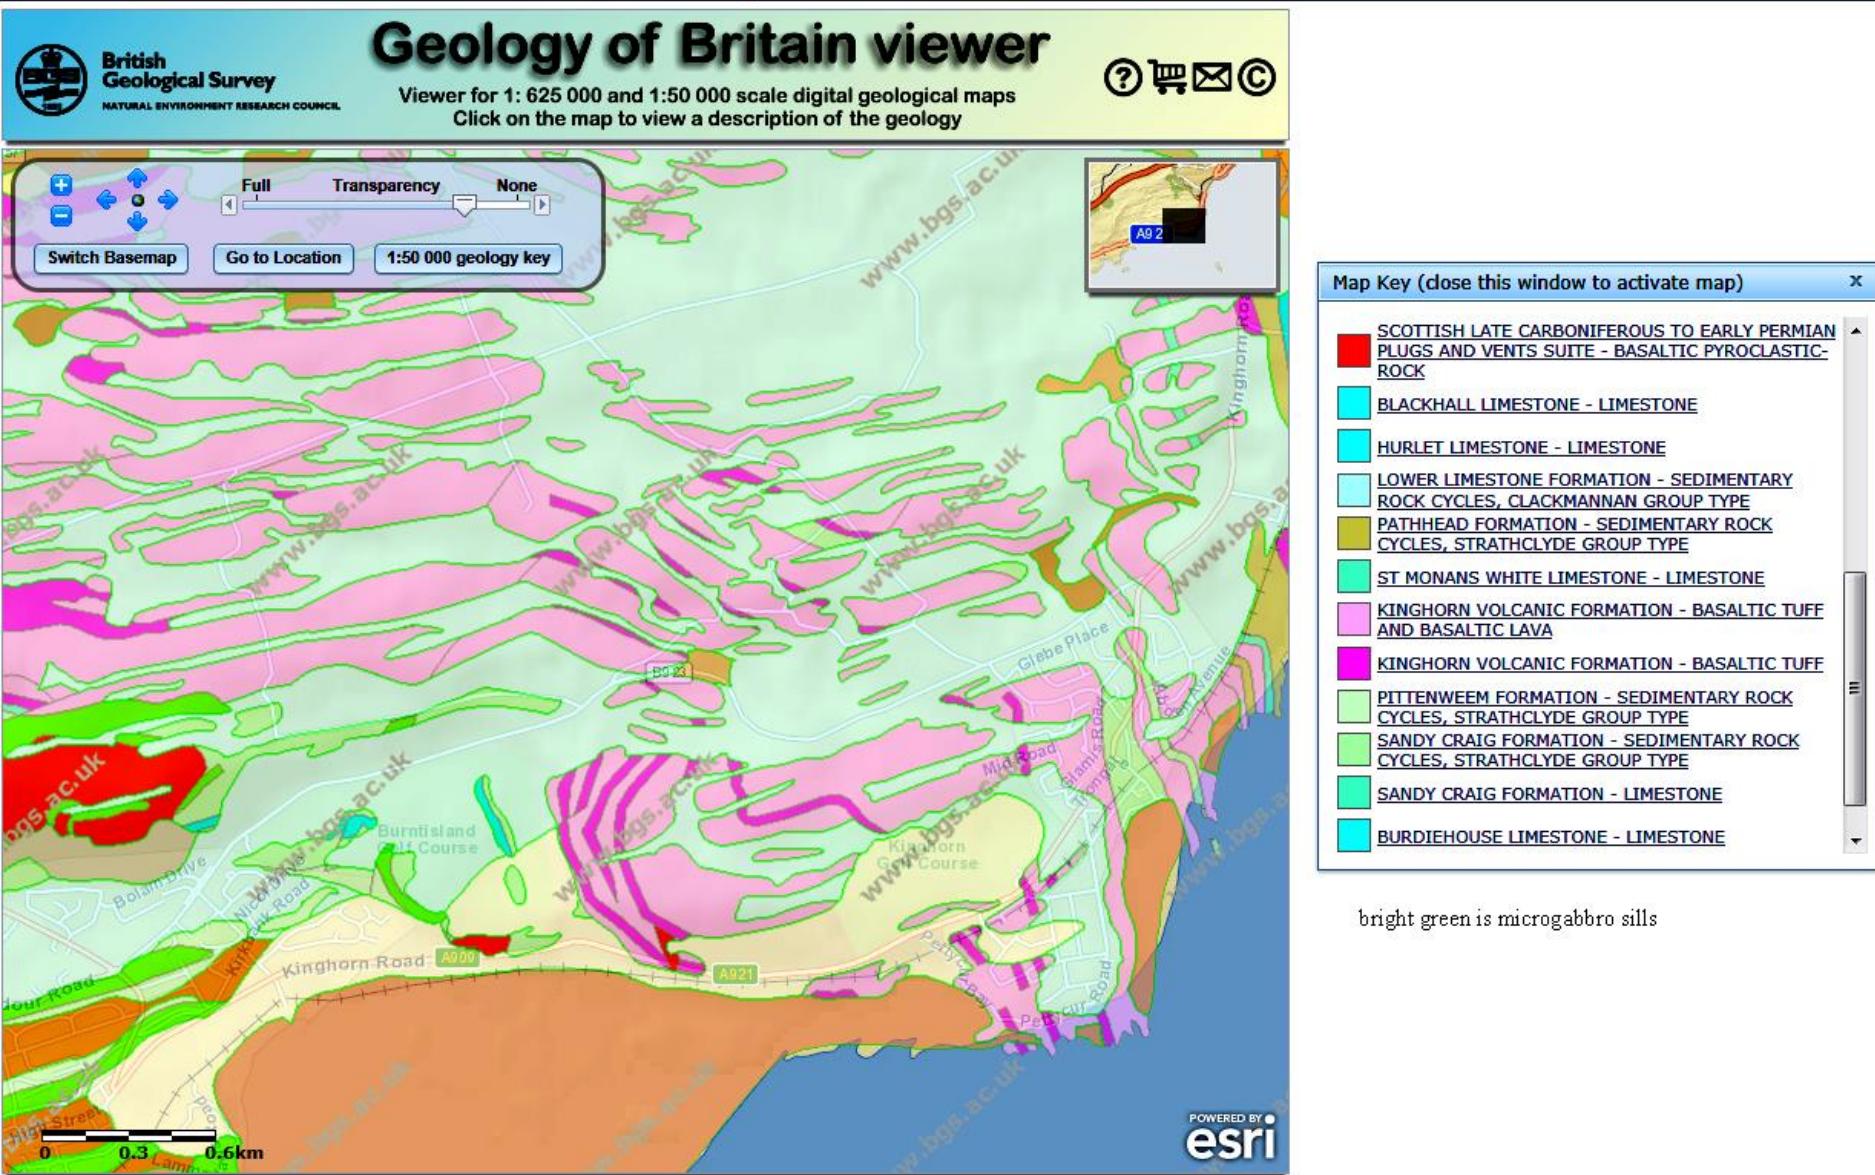
Topography of the loch area.

- The hills and dips around the loch are caused by hard basalt lava rocks forming the ridges and soft sandstones and limestones forming the shallow valleys and dips in between.
- These were dramatically emphasised by the scouring of the ice giving lochans and bog in the low areas and rocky ridges above – all of which has been softened in the millennia since.
- Deep rocky gorges were formed through Craigencalt to the loch and through to Linton Court by glacial meltwaters, most of which has filled with deposits.
- Craigencalt probably means “gorge of the wildcat”.

Pink shows each lava bed.

Red volcanic plug and green sills are also seen.

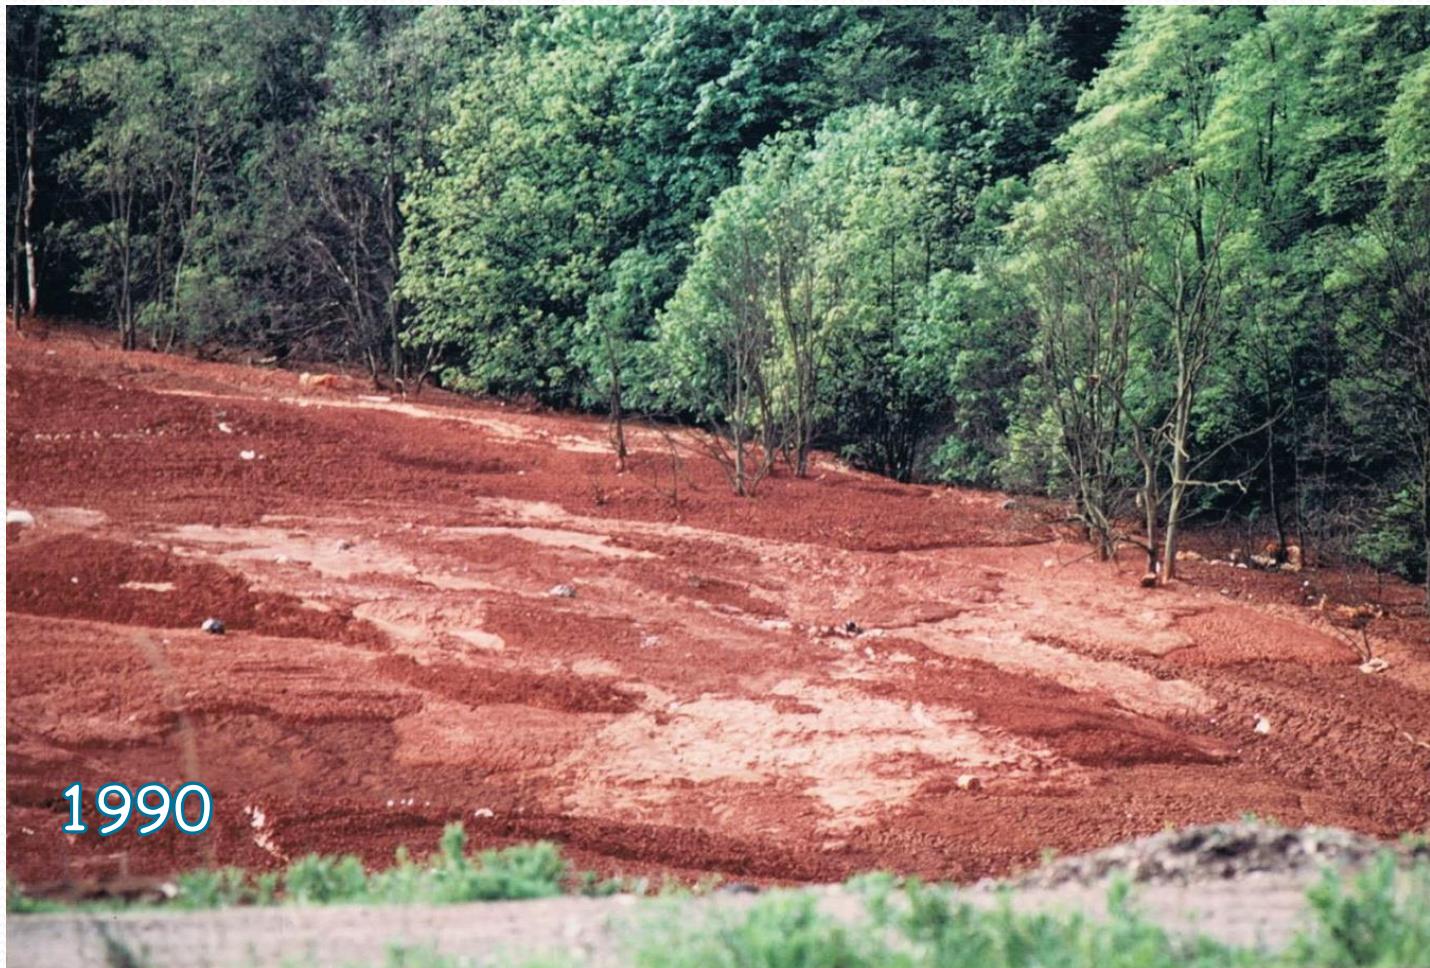
Whinnyhall Landfill Site

- Red Mud was deposited in the Sea Mill Dam sea inlet up until 1950s. Disposal at sea was a common and effective solution to Red Mud disposal throughout the world.
- Disposal to Whinnyhall commenced in the 1950s and as production increased so did the tonnage of Red Mud.
- Up until 1983, leachate escaped from the tip to pollute the Kirkton Burn and Kinghorn Loch.
- From 1983, the leachate was treated before discharge to sea.

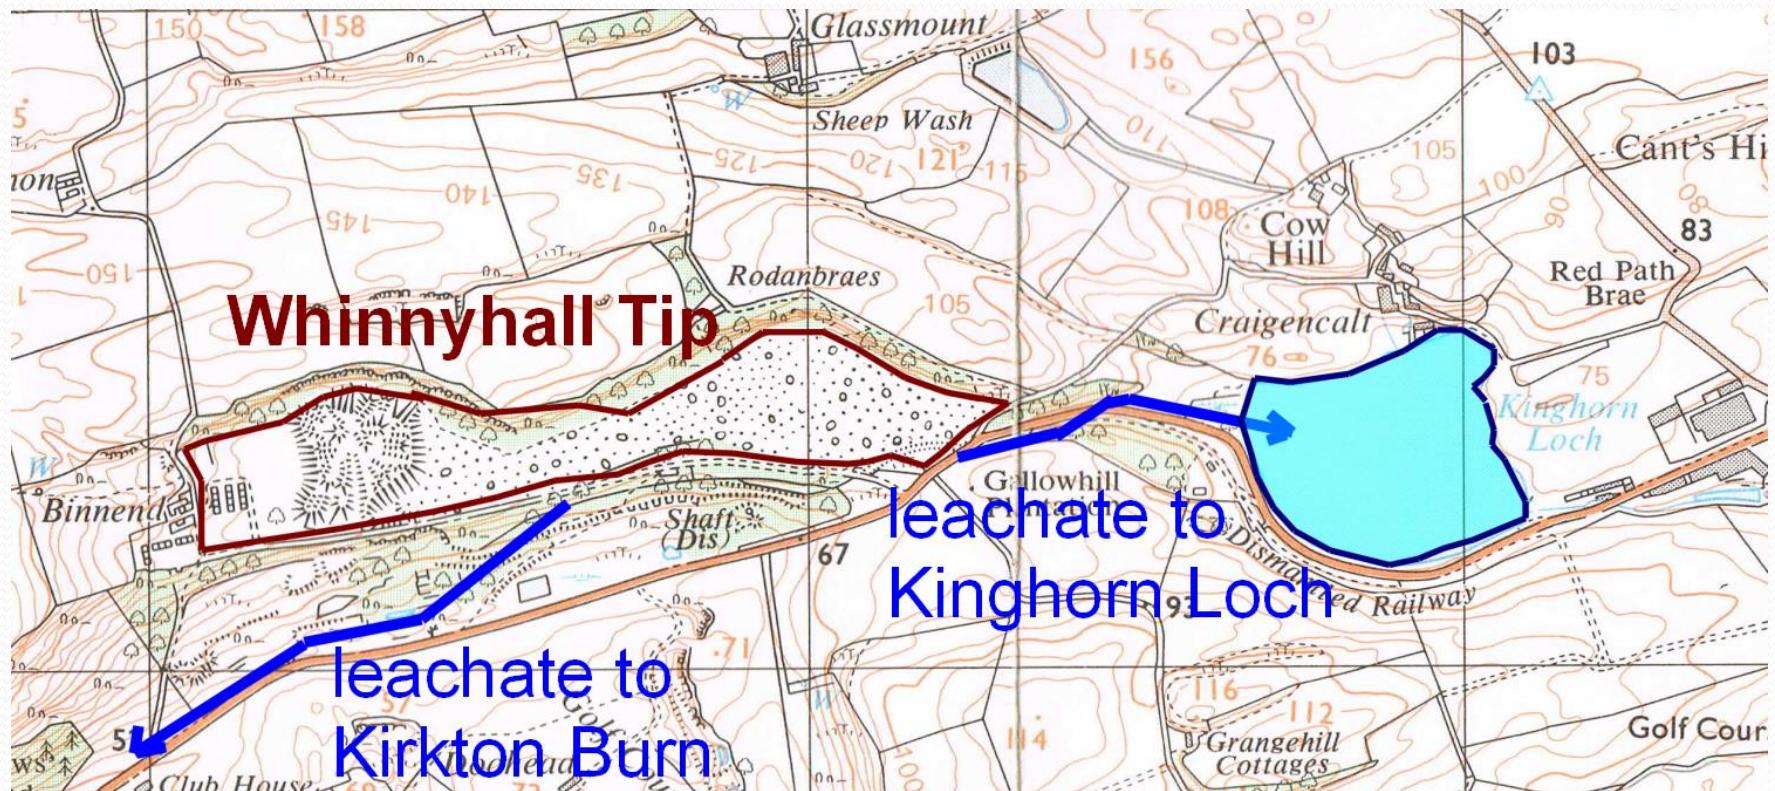
Source of the leachate

Both leachates redirected for treatment by 1983

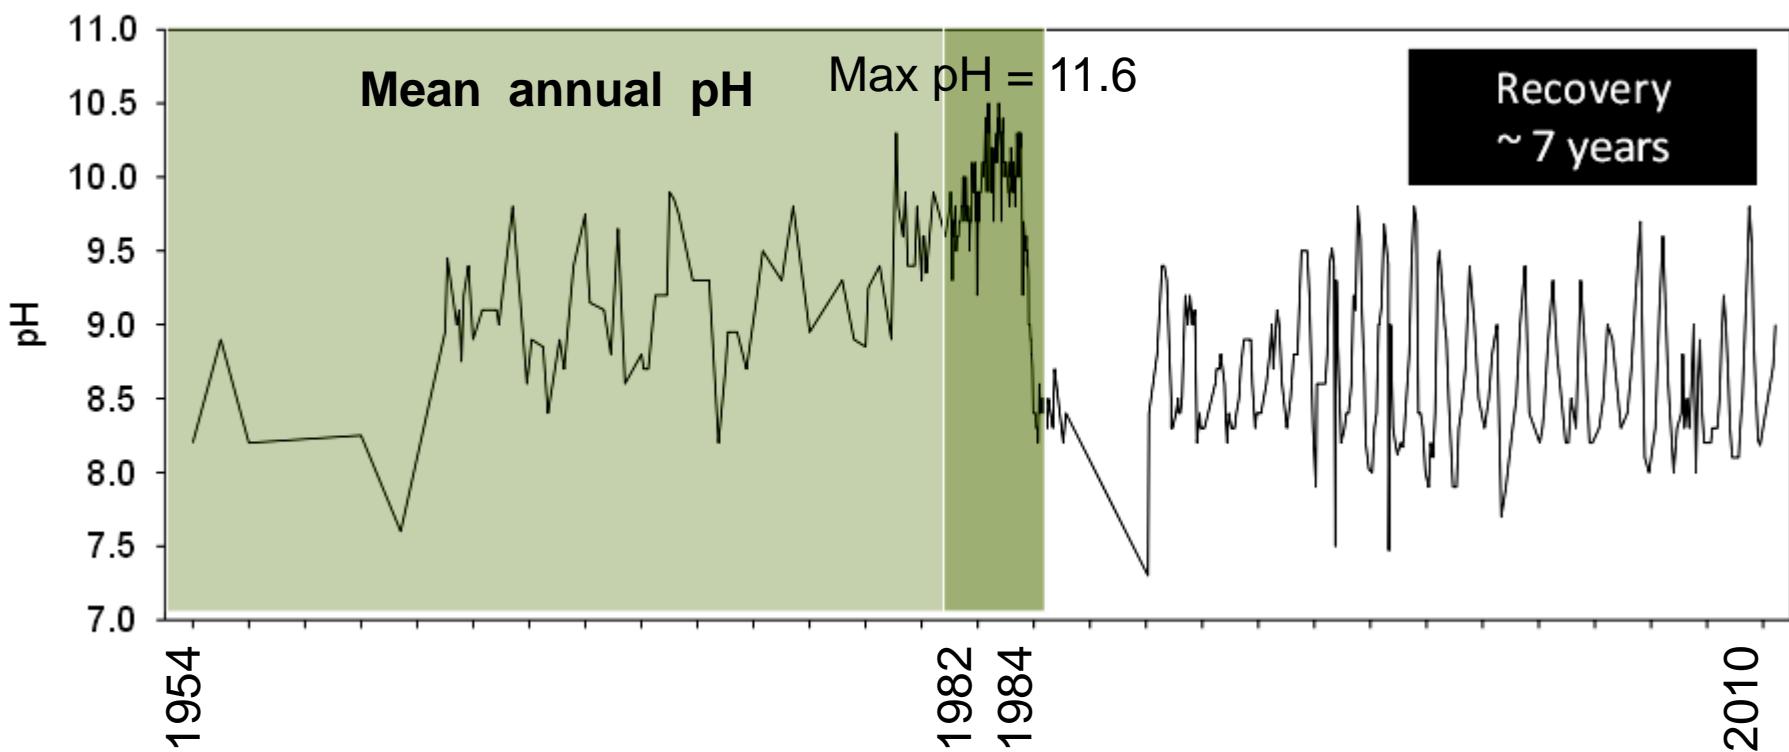
Rising pH of the loch water

- Sodium carbonate (“Washing Powder” in solution)
- Sodium bicarbonate (“bicarbonate of soda” in solution)
- Hydrated iron oxides (as fine mud, silt and sand)
- Sodium arsenite & arsenate (traces in solution)
- Phosphates
- Vanadium and other metals (traces of salts in solution)

- Sodium carbonate and bicarbonate raised the pH of the water, which, together with depositing “lime” on plants, killed all plants and fish.
- Dissolved arsenic was ten times the Environmental Quality Standard and the highest in any water body in UK. Midge larvae was dominantly *Chironamus plumosis*, an arsenic tolerant midge.
- Dissolved aluminium was deposited in the sediment.
- Phosphates together with natural levels of nitrate allowed rampant development of algal blooms.
- The significance of vanadium remains unknown.

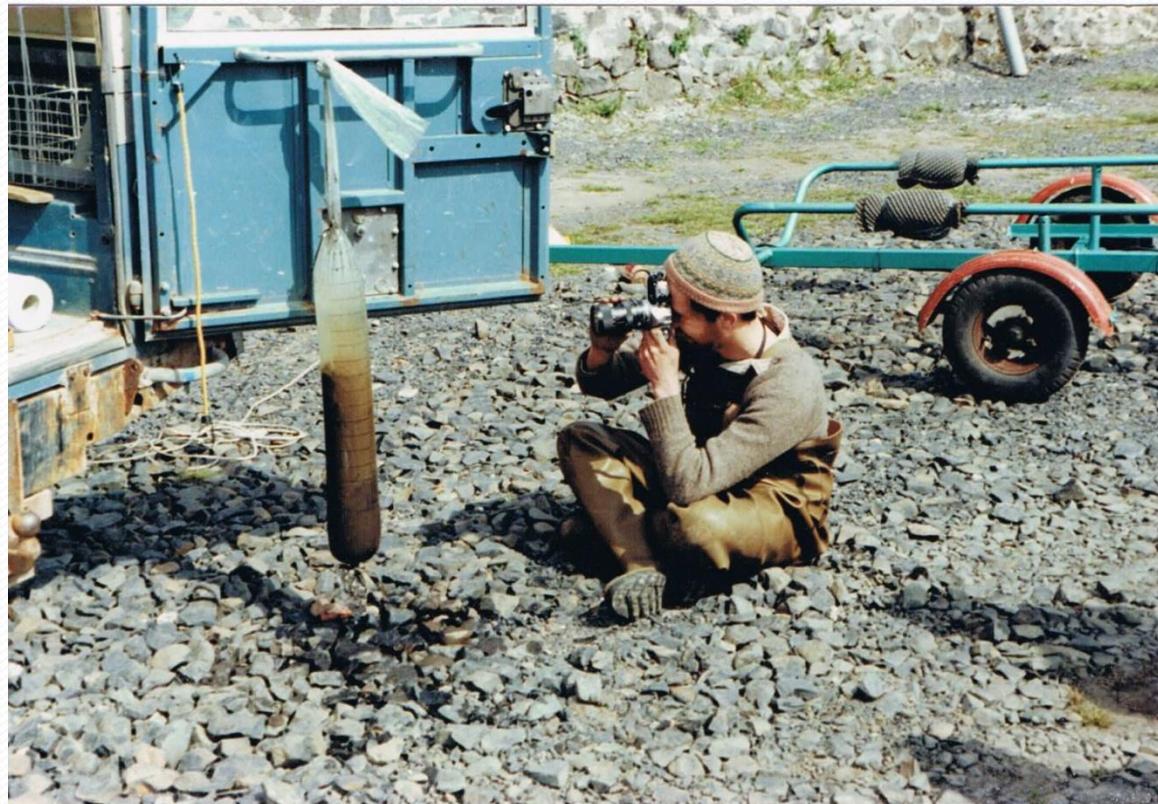
1985

- Thick layer of iron rich sediments
- Soaking up arsenic and phosphorus into sediments
- Local waters are nitrate rich
- Phosphorus is the limiting nutrient

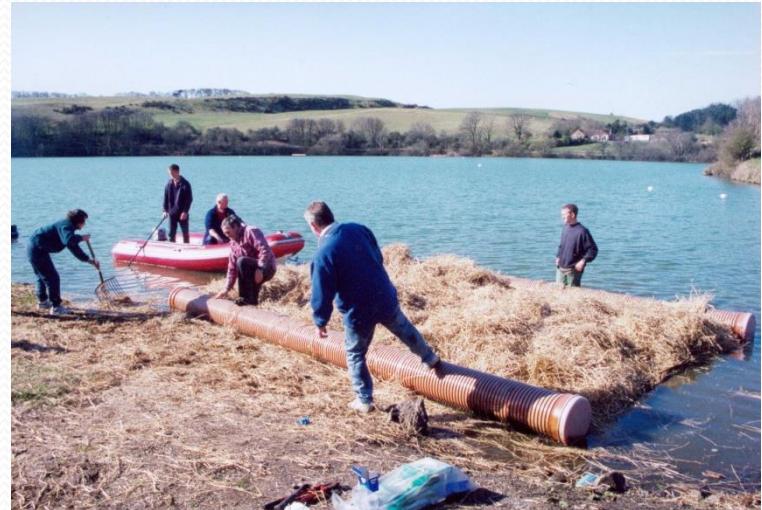
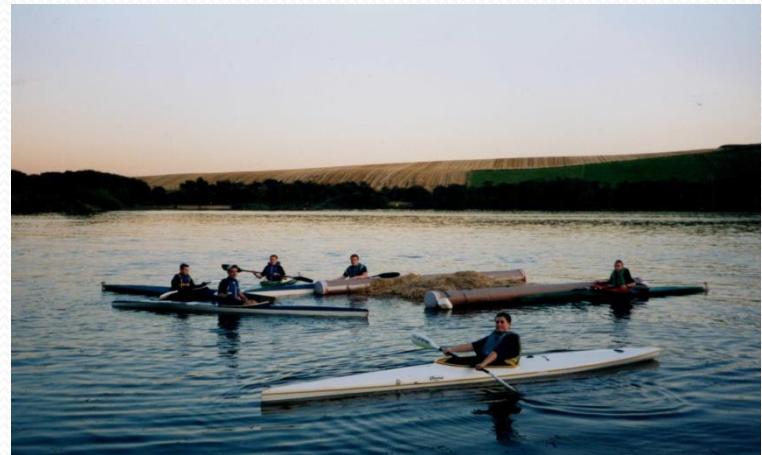
Coming together to treat the problem.

- Barley Straw rafts since 2001
- Six bales put out, twice a year, has to be totally feathered to be effective
- Rafts were designed by KLUG and built mainly with donated material
- Straw is donated by a local farm

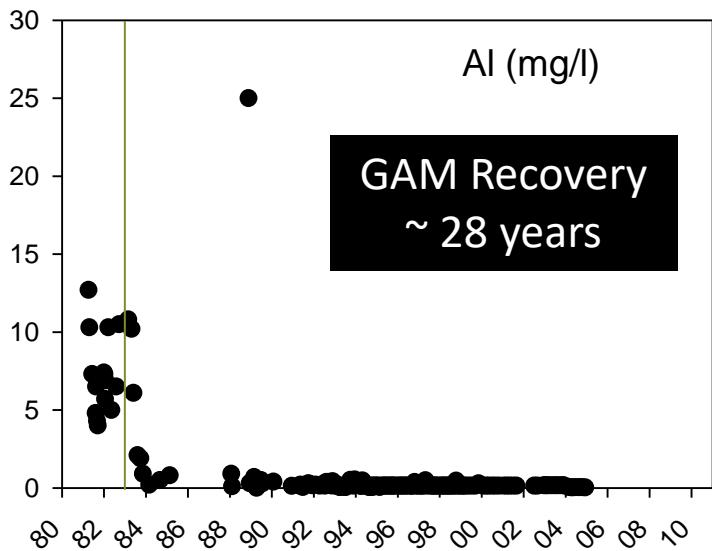
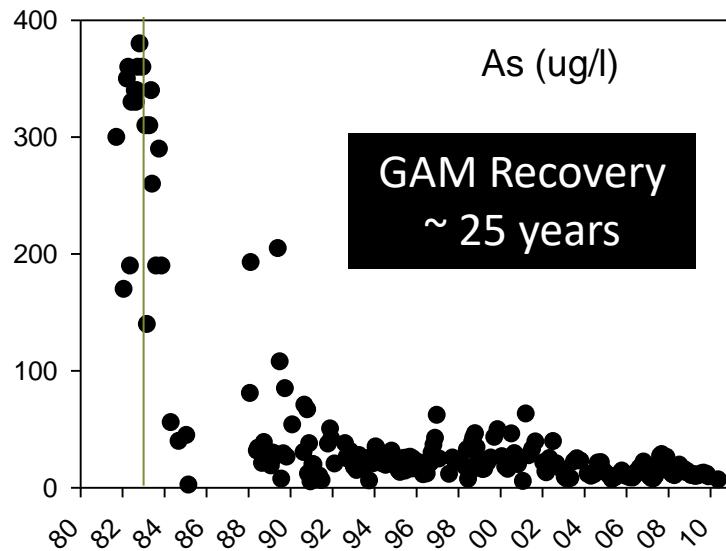
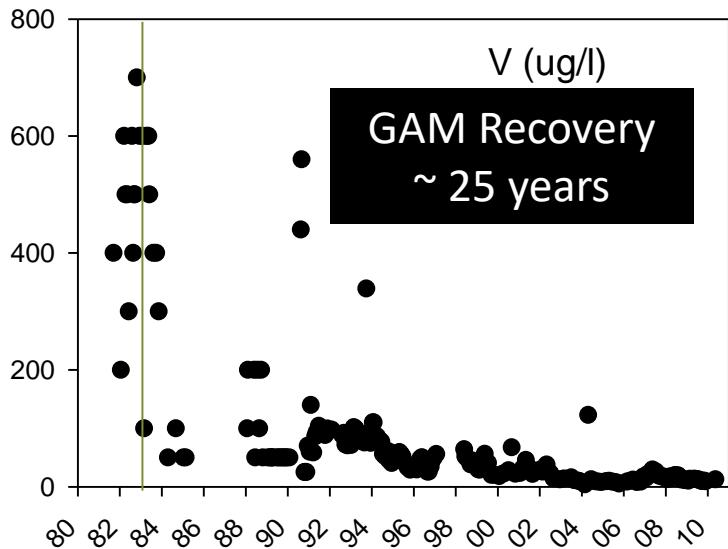
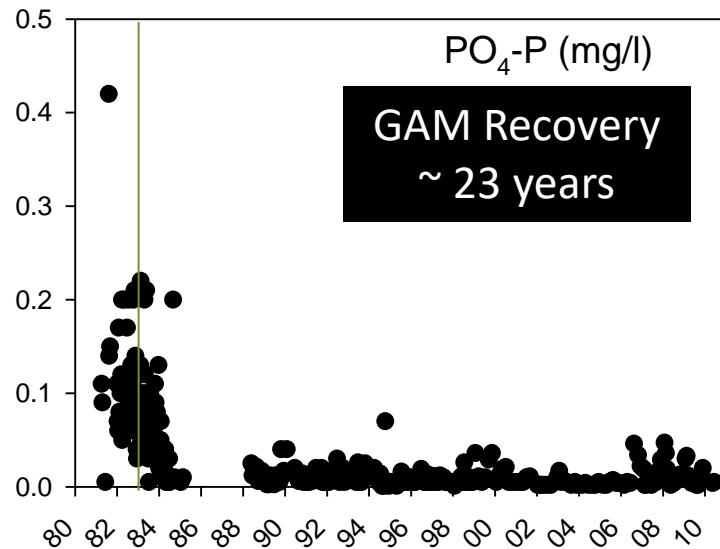
The long term chemical recovery in the water column

- Red mud pollution appears to drive multiple ecological pressures in contaminated lakes
- Recovery can take decades and is pollutant specific
- Sediments in Kinghorn Loch are still contaminated after 30 years
- Pollutant cycling between sediments and water column is still evident 30 years following management
- Metals and metalloids are accumulated in aquatic food web after 30 years of recovery
